**PENNSYLVANIA
ID NO. PA.00608**

PENN FOREST DAM

**PHASE I INSPECTION REPORT
NATIONAL DAM INSPECTION PROGRAM**

JUNE 1978

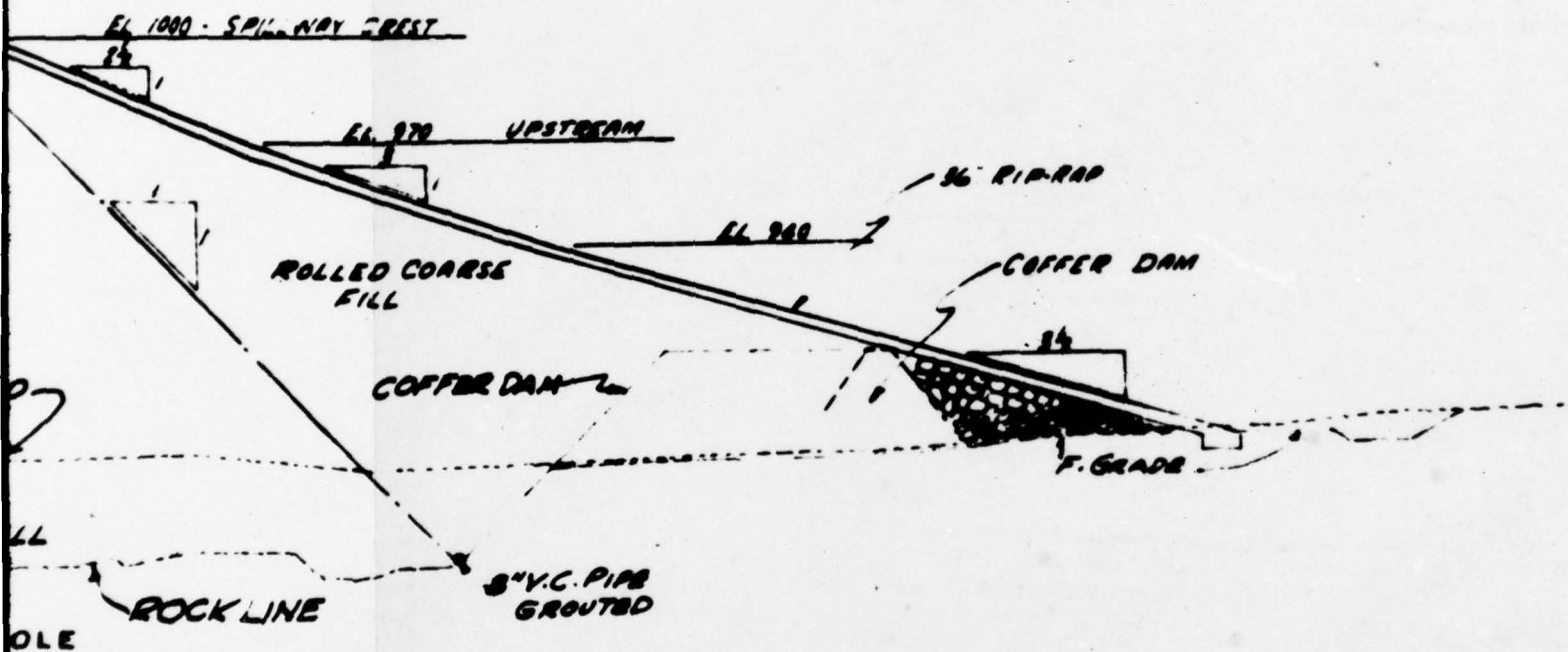
PLATE 3

Rock fill toes are shown at the upstream and downstream sides of the dam. Embankment slopes vary from 2:1 (H:V) to 3.5:1 (H:V) as shown on Plate 3. A three foot cover of stone riprap overlying a one foot thick filter bed of sand and gravel is shown on the upstream face of the dam. The application report indicated that a safety factor of 1.5 was estimated for the embankment design.

TYPICAL EMBANKMENT SECTION
 PENN FOREST DAM & RESERVOIR

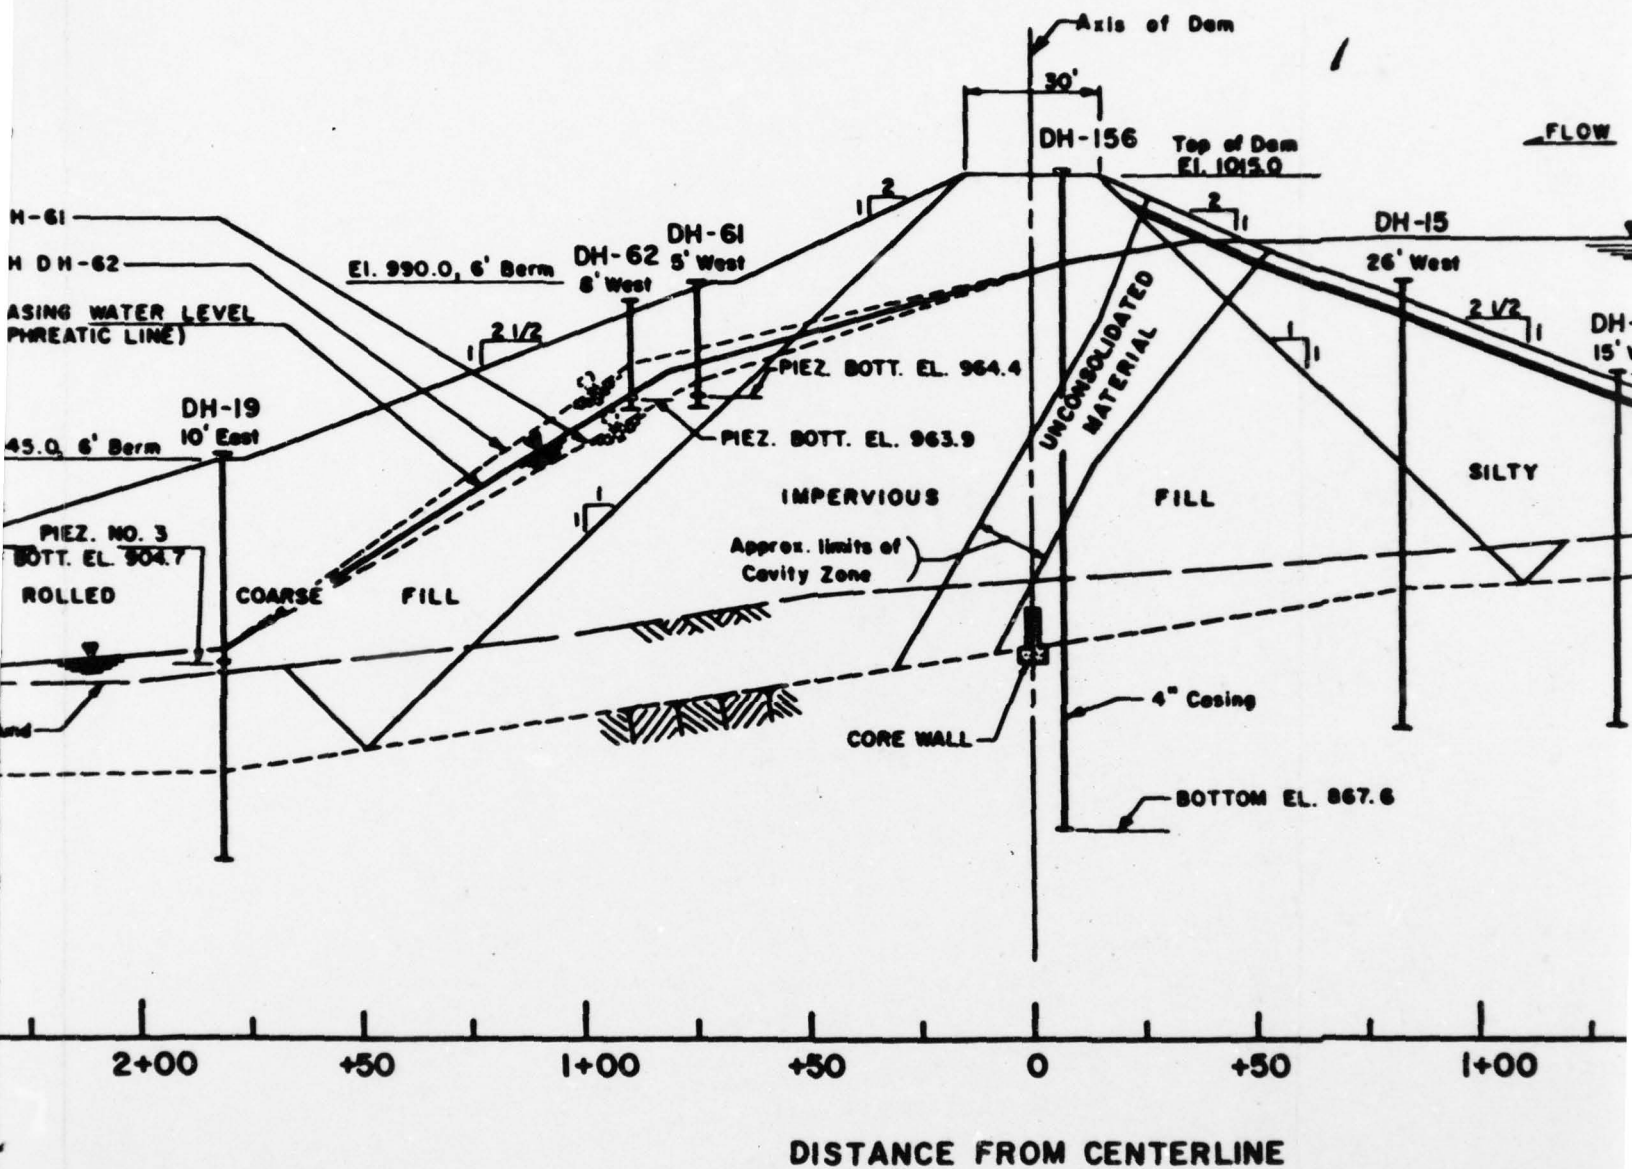
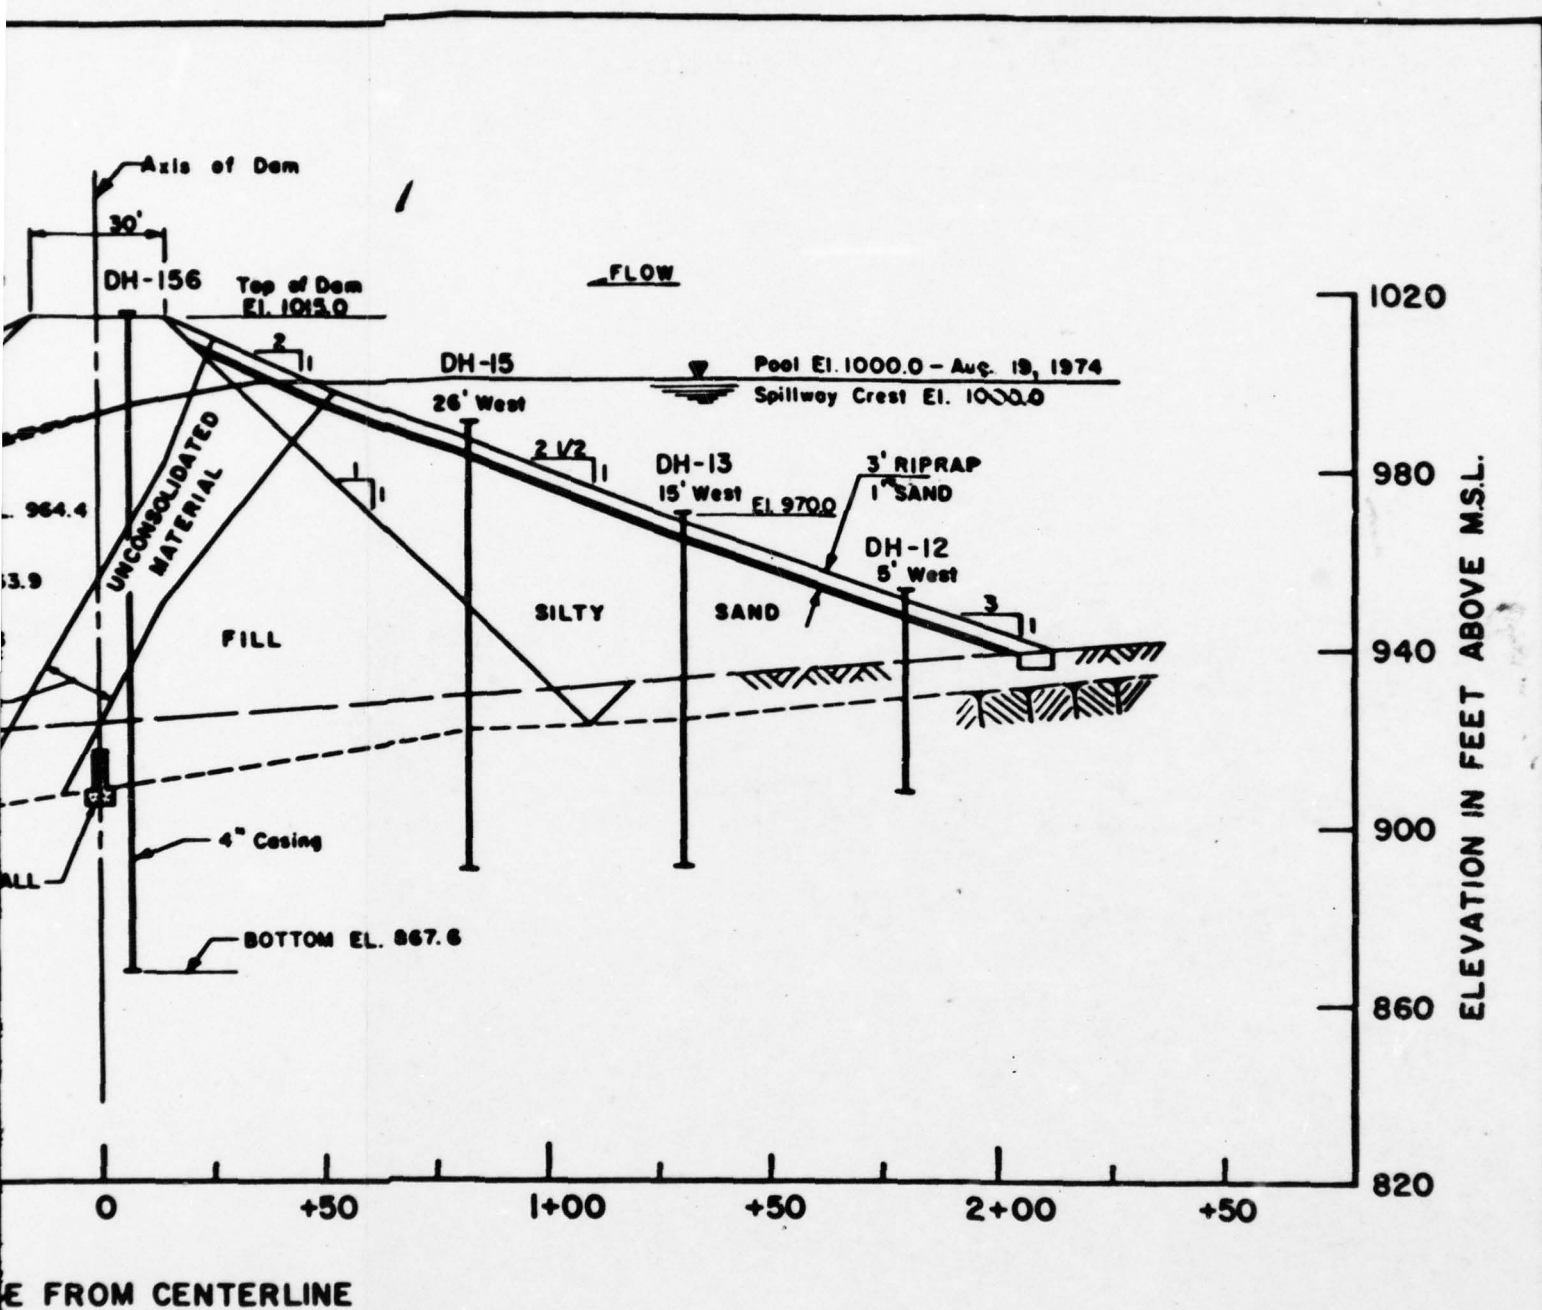
The monitoring of the dam was continued until the present time. A report issued in 1975 after several years of "normal" operation of the dam concluded that no detrimental conditions existed. Based on the monitoring information, conclusions about the conditions of water flow through the dam, such as illustrated on the cross-section in Plate 11 of Appendix E, which is taken in the vicinity of the sinkhole, were developed.

TYPICAL SECTION SECTION A-A IN
VICINITY OF STATION 4+40 W
